TEST REPORT

Report No.: D170712634_1

Sample description: LEFT SHOES:HIGH CUT"CALZADO DE SEGURIDAD HW BERING - ALTO"
RIGHT SHOES:LOW CUT"CALZADO DE SEGURIDAD HW BERING - BAJO"

ASTM F 2413 : 2011

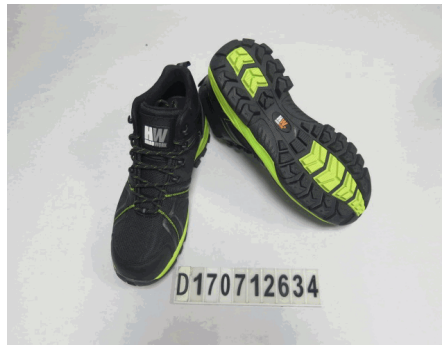
D170712634

<u>Size</u>	<u>Analyzed product</u>	<u>Description</u>	<u>Sample information</u>
--	Safety shoes (2 pcs)	Whole footwear	Black/yellow
